Manhole Inspection Summary

Manhole # S23W__009MH

Location Address: **Wicomico St** Cross Street: **Ontario St**

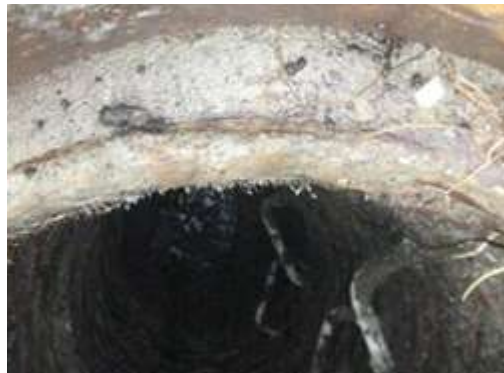
Defect 3

Frame Offset: **3** (in.) Condition: ☐ Sound ☐ Cracked ☒ **Leaks**

frame offset 3 inches, frame leaks

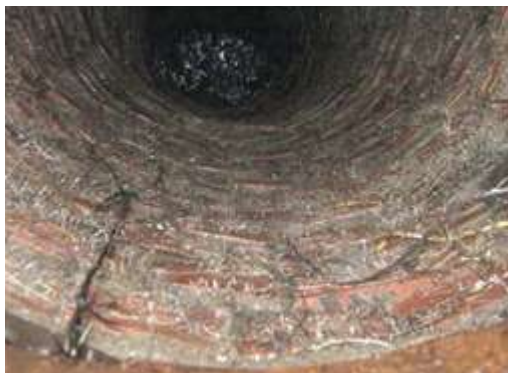
Defect 2

Condition: ☐ Sound ☐ Cracked ☒ **Root Intrusion** ☐ Loose Brick ☐ Deteriorated

Infiltration: ☐ None ☐ Joint ☐ Cracks ☐ Mortar ☒ **Roots** ☒ **Wall**

corbel roots and infiltration at roots, corbel infiltration at wall

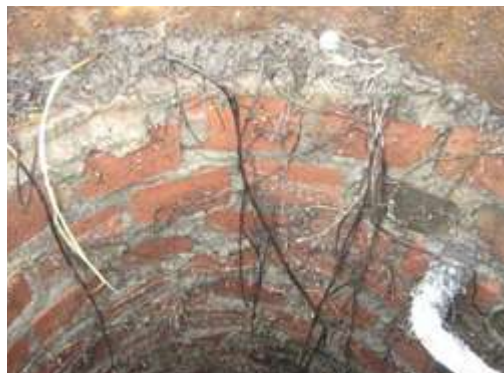
Defect 1

Condition: ☐ Sound ☐ Cracked ☒ **Root Intrusion** ☐ Loose Brick ☒ **Deteriorated**

Infiltration: ☐ None ☒ **Joint** ☐ Cracks ☐ Mortar ☒ **Roots** ☒ **Wall**

Steps Count: **14** Missing: **0** ☒ **Corroded**

chimney roots and infiltration at roots and wall, chimney deteriorated, chimney infiltration at frame joint, steps corroded

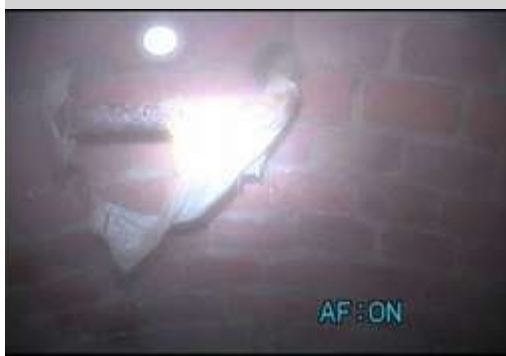
Defect 4

Surcharge ☒ **Evidence Of Surcharge** Depth: **3** (ft.) ☐ Active Surcharge Present

surcharge evidence 3 feet

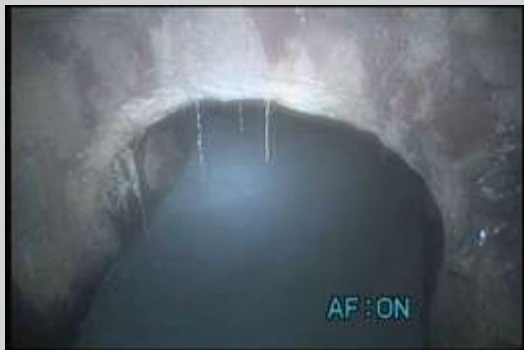
12 O'Clock Outflow

24 in. Circular Gravity Sewer
Pipe Out @ 12 O'Clock

Infiltration: **None** Pipe Seal Cond: **Sound**

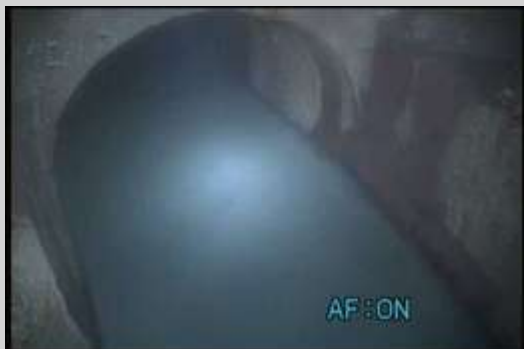
5 O'Clock Inflow

24 in. Circular Gravity Sewer
Pipe In @ 5 O'Clock

Infiltration: **None** Pipe Seal Cond: **Sound**
